Reading Abbey

North Transept

Mortar analysis

2019

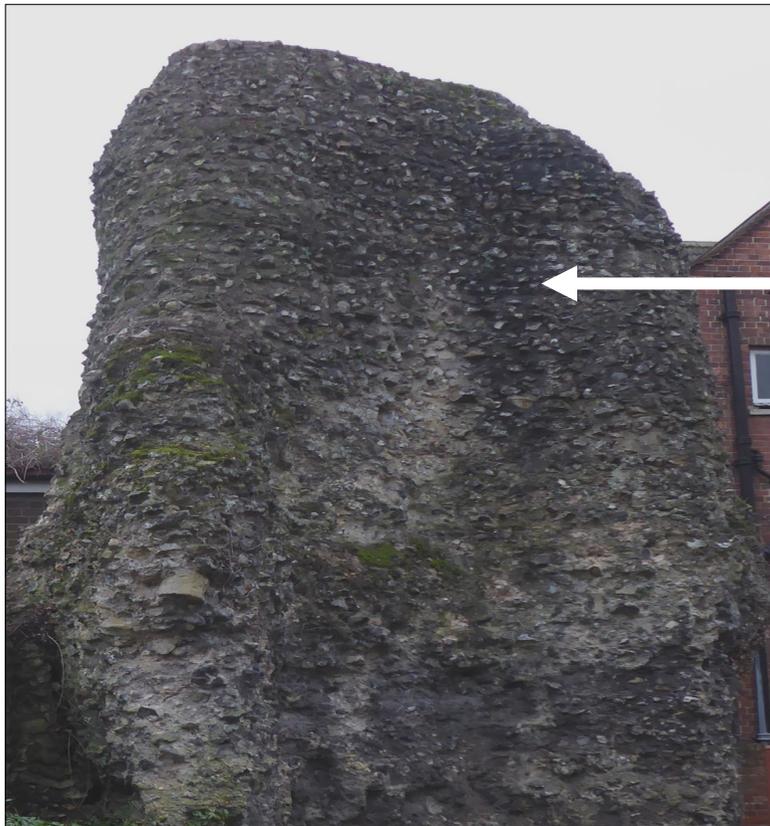
5 m approx.

Flint core of the apsidal chapel. 2018.

The main question was to what extent the standing ruins represent the original ruined structure or whether they had been altered in some way. The formation of the flint core appears to differ at a higher level, roughly from between 3 to 5 meters, as can be seen on the photograph. It was suggested by both Historic England and by Reading Museum that this may be the result of some conservation work in the 19th or 20th centuries.

Flint core from above 3 to 5 meters approx. appears to have been layered in courses rather than backfilled.

One explanation for this is that up to a certain level the builders may have built up the ashlar blocks or wooden shuttering and poured in the infill mix of flint, cement and other material. Above a certain level, say 3 to 5 meters, it was easier to layer the core in much the same way as a modern bricklayer would build a wall. This would account for the difference in the appearance of the composition between the two levels. In the lower sections there is much more mortar and other infill material, whereas the upper levels are in courses, with the flints bound more tightly together. There is evidence that this was done on the other parts of the Abbey site and that the technique of herring bone layers was used to strengthen the courses. This latter was used by builders of Cluniac monasteries in France, and it should be remembered that the first monks called to found Reading were Cluniacs brought over to England by Henry I in 1121. It was, however, a comparatively widespread method, with examples in England stretching from the Roman era, through Saxon times and throughout the middle ages. See 'Comment 2' below'.

The conclusion must be that the structure dates to the medieval period and that the area with the layered appearance, therefore, likewise dates to the same time frame. In short the layered flints are not a modern rebuilding.

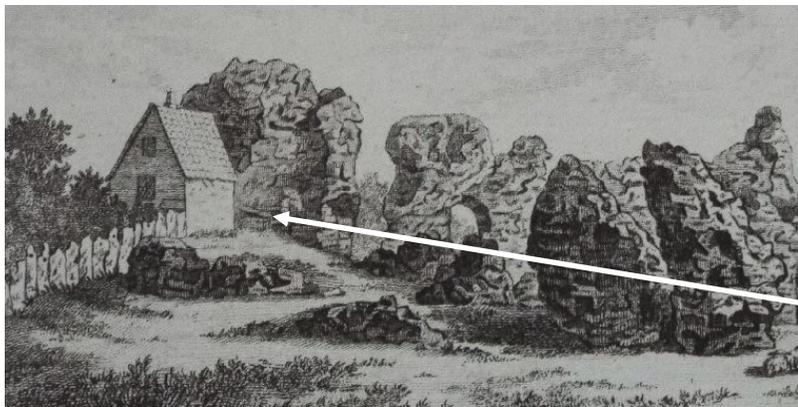
The overall height of the standing remains is about 8.15m. (Harrison *The North Transept*. p3). However, one anomaly is that an 18th century illustration, (below left), does not appear to show the same profile as in a late 19th or early 20th century photograph, (below).

A small house built by the late Lord Fane

In 1779 Sir Henry Englefield of Whiteknights wrote a paper with an illustration showing the results of his archaeological survey. He reproduced a fuller version for Coates' 1802, *History and Antiquities of Reading*. This is the plan shown here. In both versions he shows a small house and its garden, which in his notes he says is, *a small house built by the late Lord Fane*. A small house is shown standing against the ruins in the illustration mentioned above. The plan shows the house in the correct position, against the ruins of the south chapel of the North Transept or, more accurately, of the north ambulatory wall immediately to its east. It should be noted that the chimney, and so flue, does not appear to be attached to the ruins. This is important for our later observations. It is possible that there were two different houses at different times.

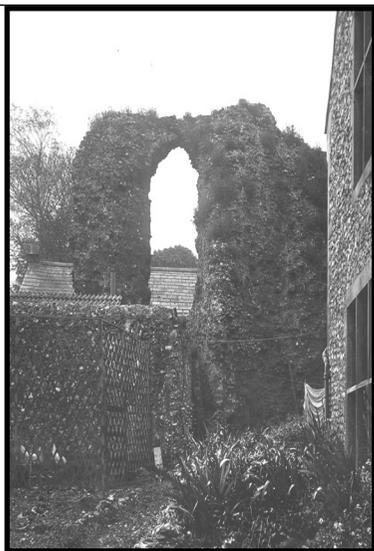
Late 19th, or more likely early 20th, century photograph showing a window opening east of the apsidal chapel.

This window would have been in the ambulatory wall, east of the North Transept. This window arch has now completely disappeared. It should be noted that Englefield, when discussing the Chapter House and other parts of the ruins, wrote, *it is now difficult to say, whether or not the windows were round headed; they have the appearance of an obtuse point, as have all the other windows remaining in the abbey, though the doors are every one round*.

This is an important observation from one who saw the ruins before the changes, restorations and conservation projects of the 19th and 20th centuries. Certainly some of the early illustrations and even photographs, such as the one shown here, could be interpreted as substantiating Englefield's observation. Note, however, that he says the evidence is inconclusive, and the angle of the point is not obtuse.

It would be interesting to examine mortar samples from the rounded windows in the Chapter House to see if they are medieval or 'modern'.

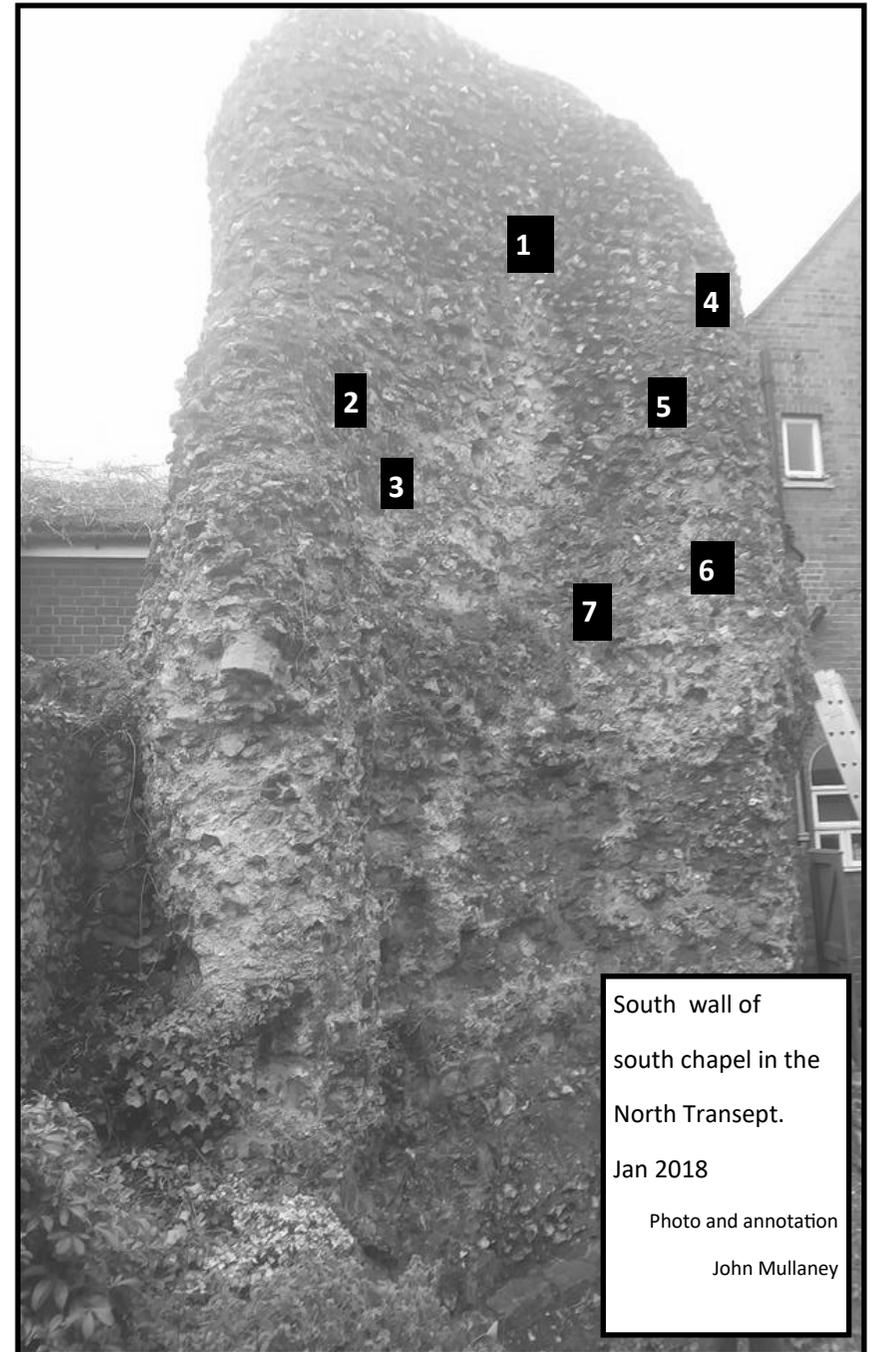
1. Type A, Light cream-grey lime gravel mortar 2.5 YR 8/1 with ovoid chalk inclusions — primary medieval mortar

2. As above

3. Mid to late 19th or 20th century mortar. ("Roman cement"). Darker colour. (See comment 1, below).
4. Type A . White grey 2.5 YR 8/1 Light cream lime gravel mortar with 25mm brown flint pebbles rare charcoal. Ovoid chalk inclusions c 10mm. Rare shell. Hummocky tufa like appearance. Possibly primary medieval mortar

5. Type A1 White gravel mortar with 25mm brown gravel flint pebbles and large ovoid chalk humps, but very similar to Type A with one small piece of White-grey 2.5YR light cream gravel mortar with 25 brown flint pebbles, rare charcoal. Ovoid chalk inclusions c10mm. Rare shell similar. Possible primary medieval mortar.

6. Type A White grey 2.5YR 8/1 light cream concretionary lime gravel mortar with 25mm brown flint pebbles. Rare charcoal. Ovoid chalk inclusions c 10mm. Rare shell. Hummocky tufa like appearance. Finer than no 4 above. Possible primary medieval mortar

7. Type A White grey 2.5YR 8/1 light cream lime gravel mortar with 25 mm brown flint pebbles, rare charcoal. Ovoid chalk inclusions c 100mm. Rare shell. Hummocky tufa like appearance . This is slightly harder than items 4 and 5 above but the same sample recipe. Possible primary medieval mortar

Samples 1 - 3 taken July 2019; samples 4 - 7 taken January 2018.

South wall of
south chapel in the
North Transept.

1. These and other samples were taken from every face of the ruins. There is little difference in the spread of the types of mortar. Most of it, by a long way, is primary medieval mortar. However, at various points, modern, so called "Roman mortar", dating from the second half of the 19th century to the 20th century, appears haphazardly both on the front face and on the reverse side of the standing remains at St James'. These consist of patches of cement which appear to have been placed over the flint and existing mortar in recent times, presumably to stabilise areas that were crumbling. They form only a small fraction of the whole.

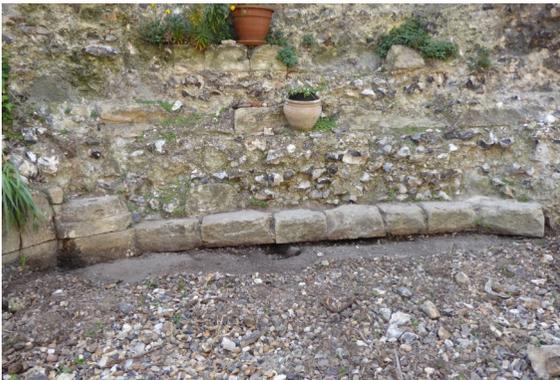
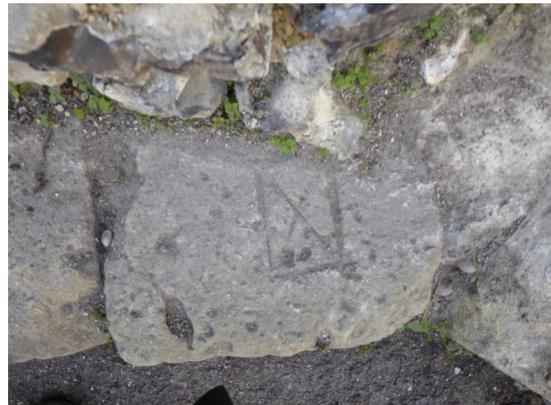
4. The dark staining on the face of the apse wall raised some questions. A representative from Historic England, among others, speculated that it may be the consequence of a fire or flue from a house. This is a possibility but, for the reasons pointed out earlier, it is unlikely to be the small house erected by Lord Fane, or at least the one shown in the illustration. One medieval specialist, Professor Anne Curry, does not believe that it could be the consequence of a fire during the time of the Abbey. One such devastating fire was recorded in the Abbey's annals for St Gregory's day, 1209. Professor Curry pointed out that it is highly improbable that the fire would have penetrated the ashlar to such an extent as to cause the discolouration visible today. Fire was a common problem during the middle ages and the evidence from other buildings does not support the theory that a fire at Reading could have caused the scorching of the core.

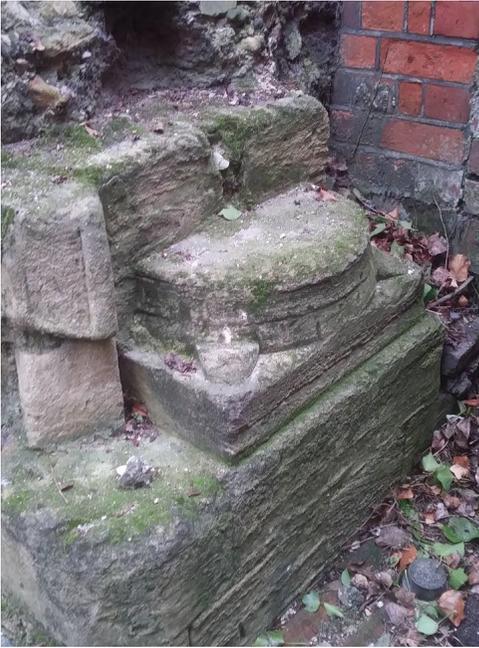
5. It is worth mentioning the stones at the base of the chapel wall. These had been hidden for many years, covered with a pile of flints and other debris. They are tied into the wall. The more easterly end has the base of a single shaft. The most westerly three stones have mason's marks, the most spectacular being a saltire inside a square. They are laid tightly together, but with room for some infill. The infill is unlike the hard mortar reported above; rather it resembles a modern dry mix. Of course it is possible that this is just dust and debris from other sources. However, there are gaps at points between the stones and so it might be expected that these would have been filled in. All are made of Taynton stone.
