**THE
CHAPTER HOUSE
OF
READING ABBEY**

John Mullaney

2021

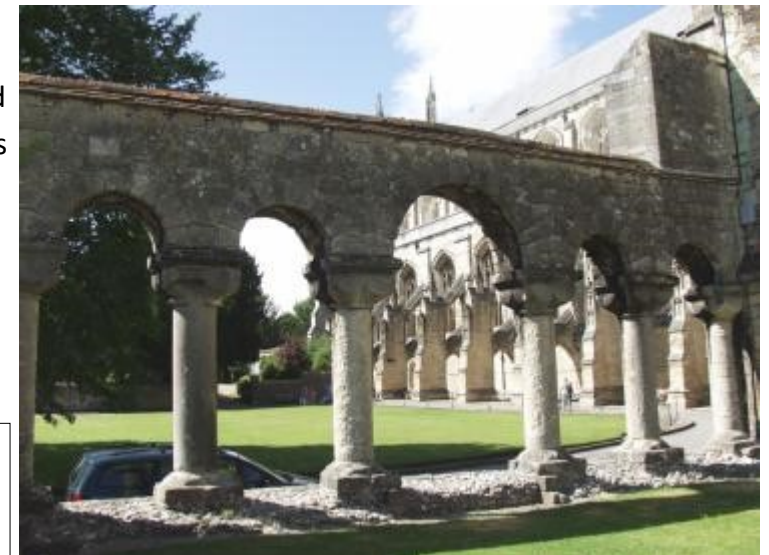
Fig 2. View of the windows and doors, from 'inside' the chapter house looking west.

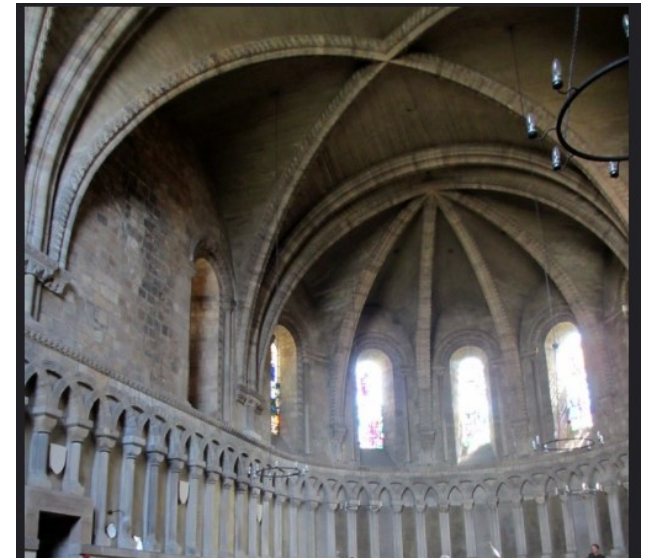
Fig 5. Apsidal east end of the Chapter House, Durham

The transverse arches were semicircular, and the ribs of the vaults had a slightly pointed soffit roll flanked by cheverons of convex profile: in the apse the ribs sprang from large figure corbels and the soffit roll was flanked by a row of star ornaments and cheverons. A wall arcade of semicircular intersecting arches ran round the building.

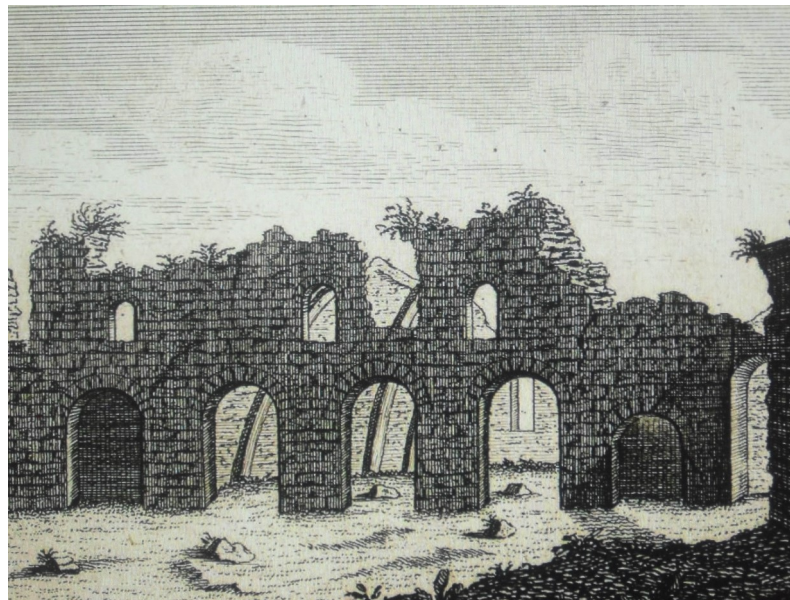
If Stukeley's drawing is accurate, the ashlar stone blocks were still in place at this time, and the windows were rounded. This latter feature needs to be borne in mind when comparing it with Englefield's account, which we shall see later. We should also note how the curvature of the vault shafts start at ground level. The standing remains and other drawings show that this was not the case.

Fig 6. William Stukeleys' drawings of c.1721 are among the first, if not the first, of the Abbey. View from the west of the Chapter House from the Cloisters.

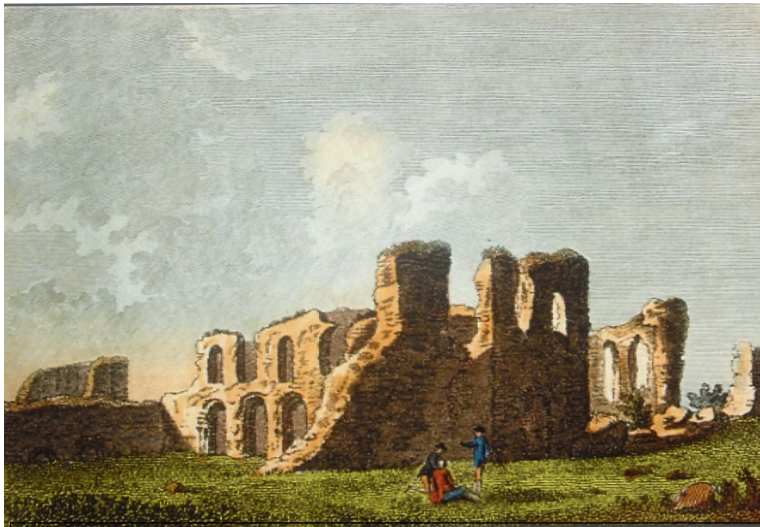
Fig 7. 1773 Godfrey (Grose)

This view, drawn only six years before Englefield's detailed report (below), shows the Chapter House behind part of the refectory wall.

We can see the three western openings, with two complete windows above.

To the east (far right), can be seen two of the great windows in the apse of the Chapter House.

The western windows appear rounded, whilst those in the apse may be pointed. This needs to be read with Englefield's statement in mind, that all the windows appear pointed.

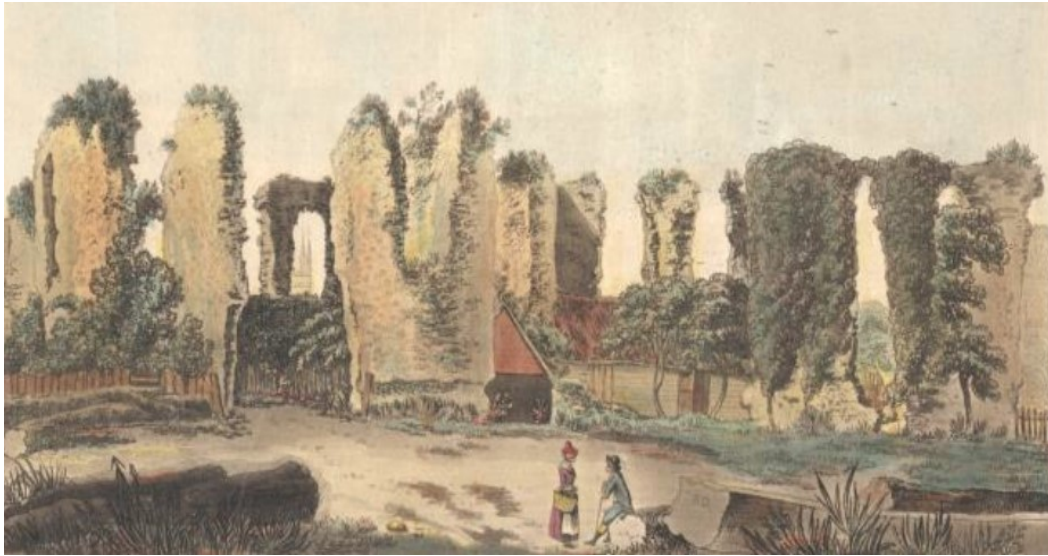
Dating to 1791, looking from the east of the Chapter House, it is possible to see where a great hole had been made in the apse of the Chapter House, nevertheless the outer frame of the two windows can be made out (fig 9). Figure 10 is another view, this time from the inside, looking east.

Fig 9. 1791 Reading Abbey. The ruins, from the east. The pinnacles of St. Laurence's Church appear in the background, and the east end of the Abbey Church is to the right. 18th century : print, entitled "East View of the Great Hall" [i.e. Chapter House], drawn, engraved and published by Charles Tomkins, 1791. No. 5 of his *Eight Views of Reading Abbey* (Reading Library)

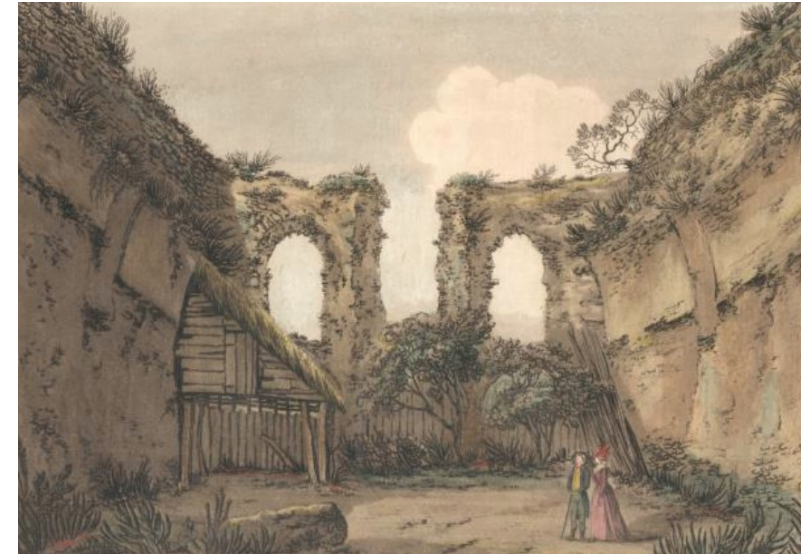
Fig 10. 1791 1791 Ruins of the Chapter House, looking west. There is a thatched, wooden lean-to building against the south wall, and two ladies pose by the north wall. Print, drawn, engraved and published by Charles Tomkins in 1791, entitled "Inside of the Great Hall". (Reading Library)

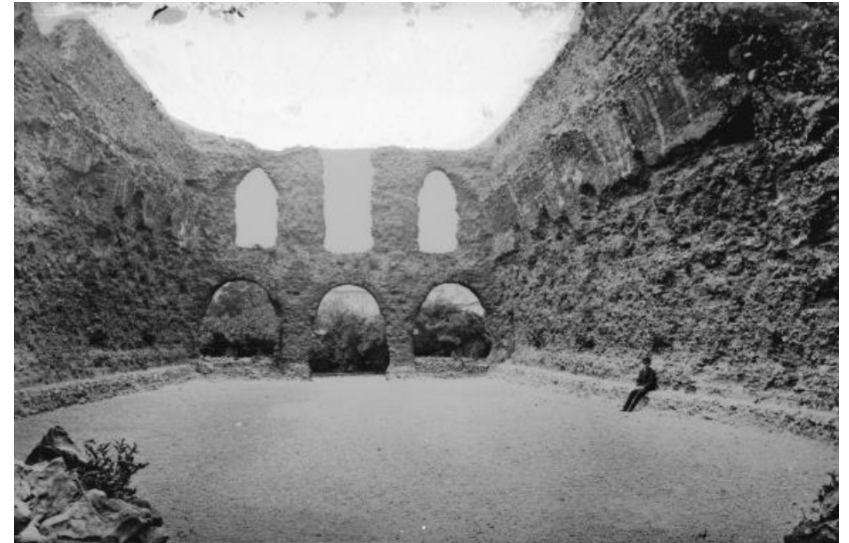
Figure 12. This is one of the earliest photographs of the Chapter House. It shows what may be pointed windows. As ever, though, one must remember that this does not mean they are the original openings.

Fig 12. 1870 –1880 Ruins of the Chapter House, looking west towards the cloister, c. 1870. A man, probably a park-keeper, sits at the base of the wall to the right. 1870-1879 ; Glass negative by H. W. Taunt, Box 22 No. 1542 (Reading Library)

Contrast this photograph with the next (fig 13), taken in the early 1900s. There is considerably more vegetation, especially around the upper windows. This would be the cause of more deterioration and structural damage.

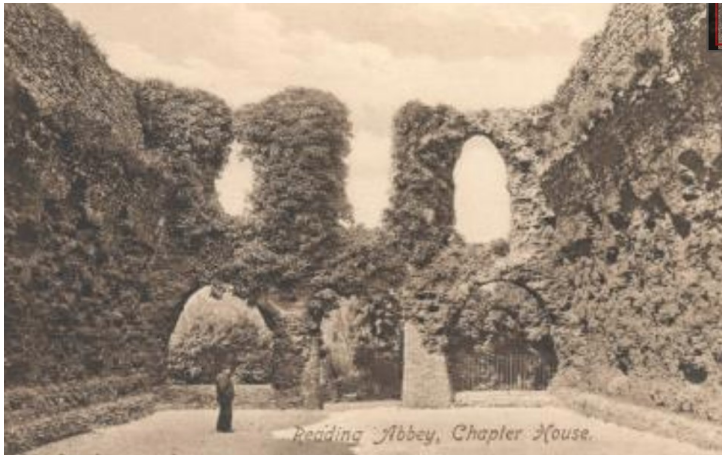
Fig 13. 1900 –1909 Ruins of the Chapter House, looking west towards the Cloister, 1908. A man wearing a hat stands on the south side. 1900-1909 : postcard by Francis Frith and Company, (Reading Library)

It is also possible to make out the two-tiered bench, which can be seen in the late 19th and early 20th century photographs shown in figures 12 and 13.

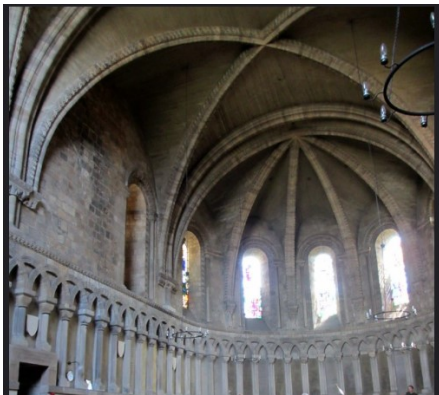
Fig 15. Durham chapter house

The east-end apse of Reading's Chapter House would have had vaulting similar to that at Durham. Although what we see at Durham is a 19th century reconstruction, it gives us a fairly accurate idea of what Reading would have looked like (fig 15).

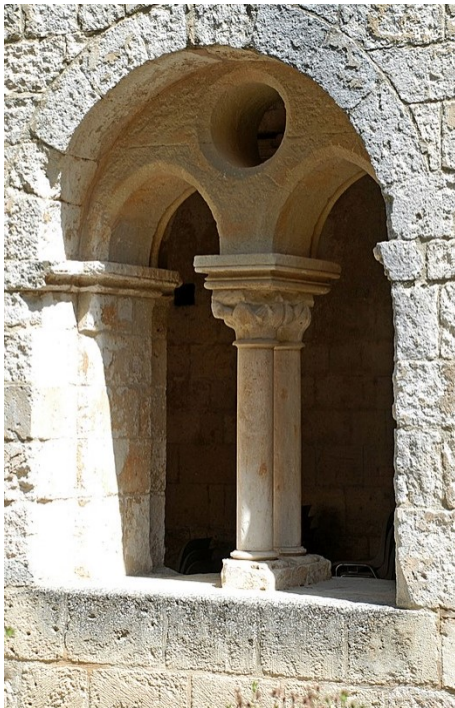
The lower windows: The window to the south of the doorway, according to Harrison's 2015 survey, shows signs of a *flanking order at each side and a projecting core along its centreline, This must be related to the plate tracery subdivision of the main opening into two sub arches supported by a central shaft.*¹³

The illustration, fig 16, is an example what this may have looked like. It is possible that the flanking orders extended the full height of the window. The possibility of plate tracery raises the question as to whether this would have been glazed.

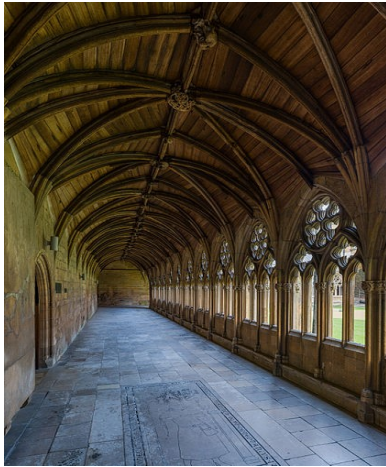
Fig 17. Lincoln cloister with door to left.
Photo by DAVID ILIFF. License: CC BY-SA 3.0"

It needs to be noted that in Cluniac monasteries, almost invariably, there was a set plan for the positioning of the cloister, the church, chapter house, refectory and dormitory. The cloister was the space which led to all the other main monastic buildings. The entrance to the chapter house would, therefore, have been from the covered cloister walkway, similar to that in figs. 17 & 18.

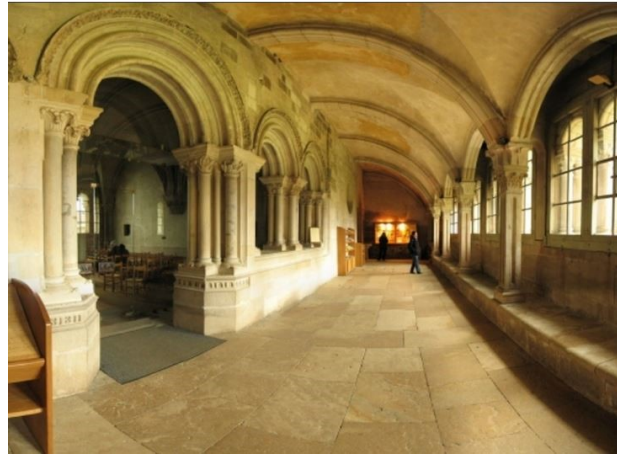
Fig. 18. Vézelay cloister and chapter house.

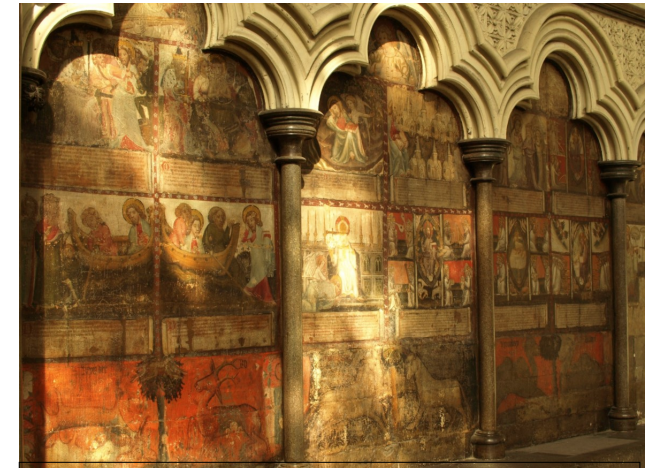
Fig 21. Westminster Abbey chapter house. Covering the walls are murals depicting the Apocalypse. They date from the 14th century.
<http://www.wilsonmj.com/2013/03/dust-jacket-bye-and-bye.html>

As for the wall surfaces, it is very likely that they were painted in much the same way as we see in the chapter house at Westminster Abbey (fig 21).

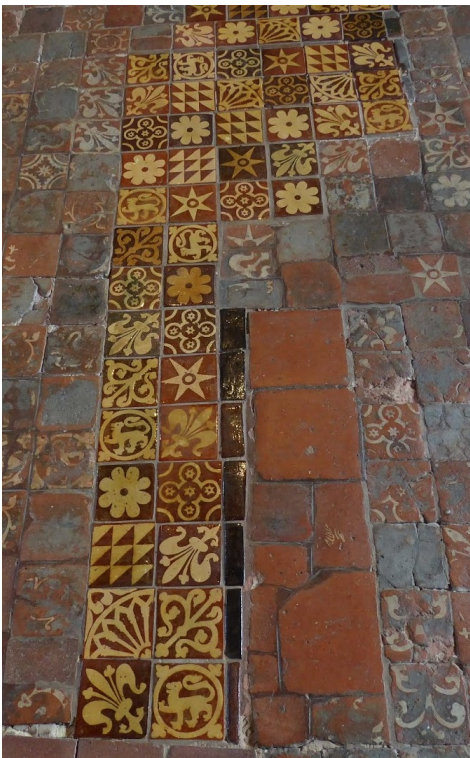
Fig 24. Medieval encaustic tiles

Whatever lay beneath it, the floor itself would have been laid with encaustic tiles. These may well have been produced locally. There are known to have been tileries dating to the 12th and 13th centuries in Reading, some having been recently excavated in south Reading on Silver Street. ¹⁶

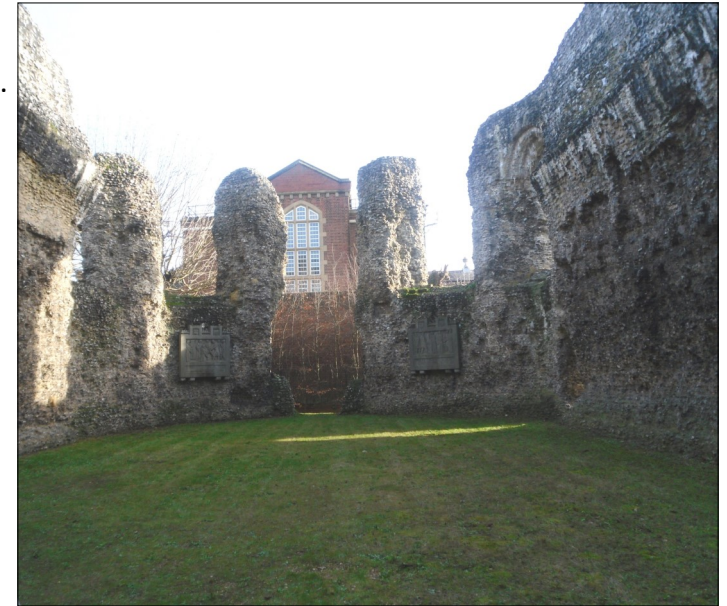
Fig 25. The Chapter House looking east, Reading gaol in the background.
